Single Diver Fatality in Cenote Nariz on 3 February 2024
CREER (Comité Regional de Espeleobuceo, Ecología y Regulación)
Line and Safety Committee Report

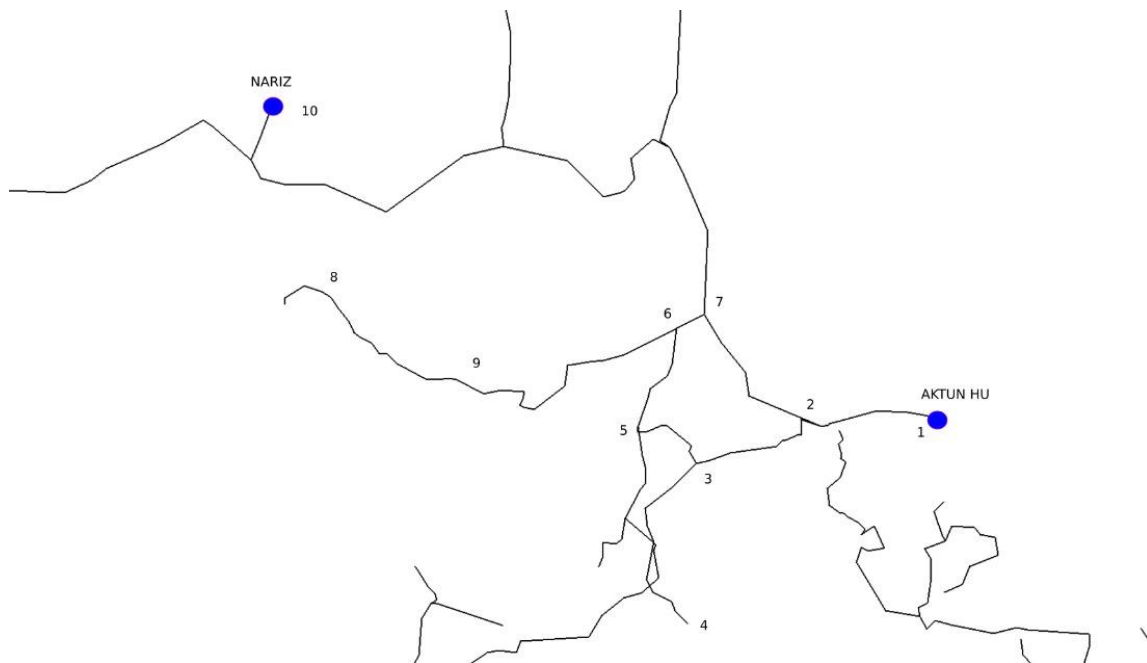
The three divers began their first dive at Cenote Nariz at 1411 local time. They swam to Cenote Aktun Hu, which took approximately 33 minutes. They surfaced at the cenote and had a conversation. The team of three divers then started their survey dive at 1451. They made their way from Cenote Aktun Hu (Point 1) and installed a jump at Point 2 approximately five minutes later.

The team started the dive to survey the lines in the area around Point 3. After approximately 10 minutes the team navigated the T left (Point 3) and swam to the end of the line (Point 4) where the cave pinches down.

They turned around and swam back past Point 3 until the other end of the line (Point 5). They installed a jump and turned right on the line, swimming towards the T at Point 6 and arrived at 1511, around 60 minutes of dive time.

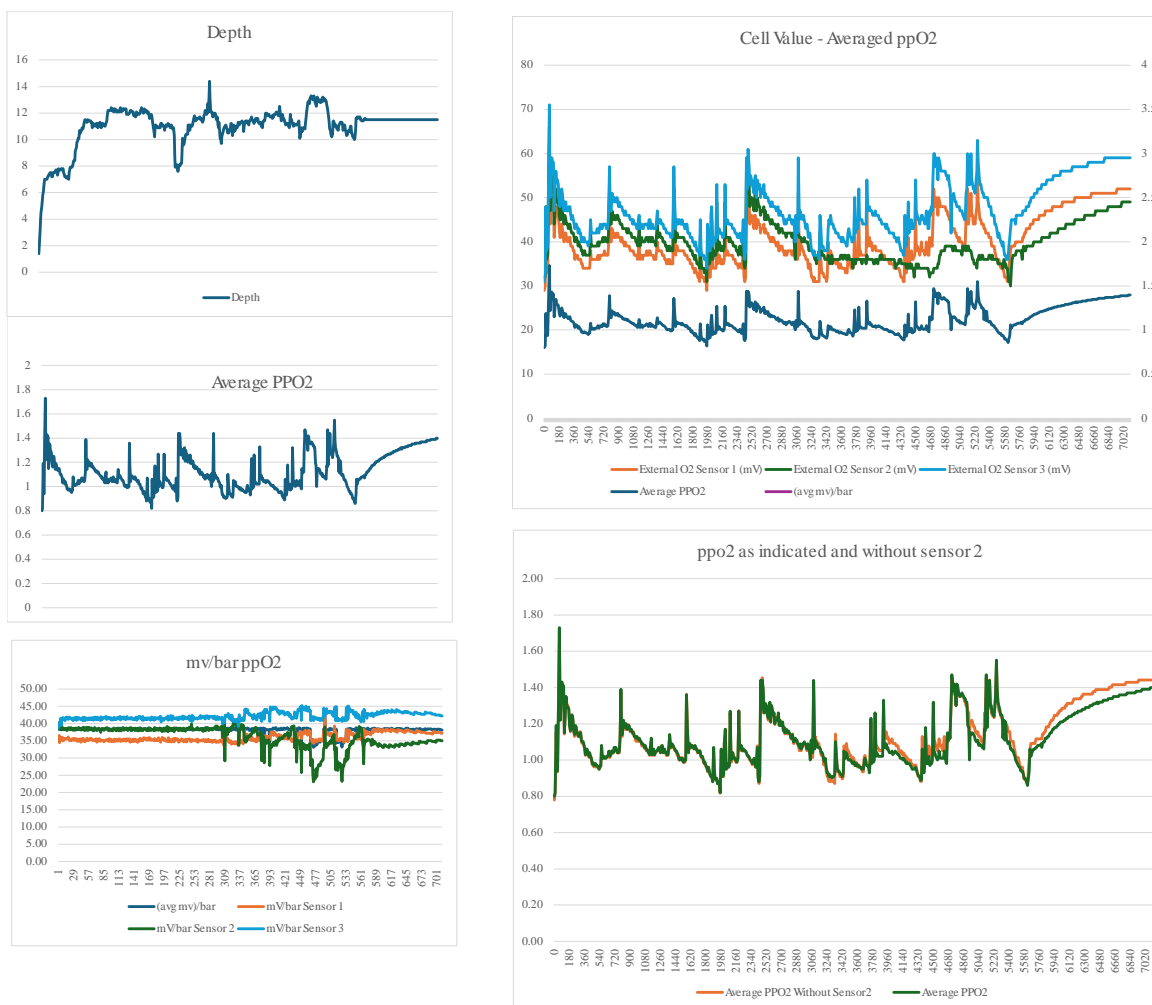
The dive computer log shows an average PO₂ of around 1.14, with a series of spikes corresponding to a manual addition of oxygen or a change in depth. This is usual for a constant mass flow rebreather. Some of the spikes approached a PO₂ of 1.6, and on one occasion at the beginning of the dive reached 1.73, but the indicated PO₂ alone is unlikely to be high enough to cause a CNS oxygen toxicity hit, unless these readings were erroneous.

Analysis of previous dives logged indicates some erratic cell behaviour and data indicates Diver 1 potentially conducted some shallow test dives to validate cells. One cell appears to stop working on a dive on 30 January

2024. It is possible that Diver 1's rebreather could still have been experiencing intermittent cell issues, but the data from the dive does not indicate high PO₂ as the sole triggering factor for unconsciousness or convulsions.
