Single Diver Fatality in Cenote Nariz on 3 February 2024
CREER (Comité Regional de Espeleobuceo, Ecología y Regulación)
Line and Safety Committee Report

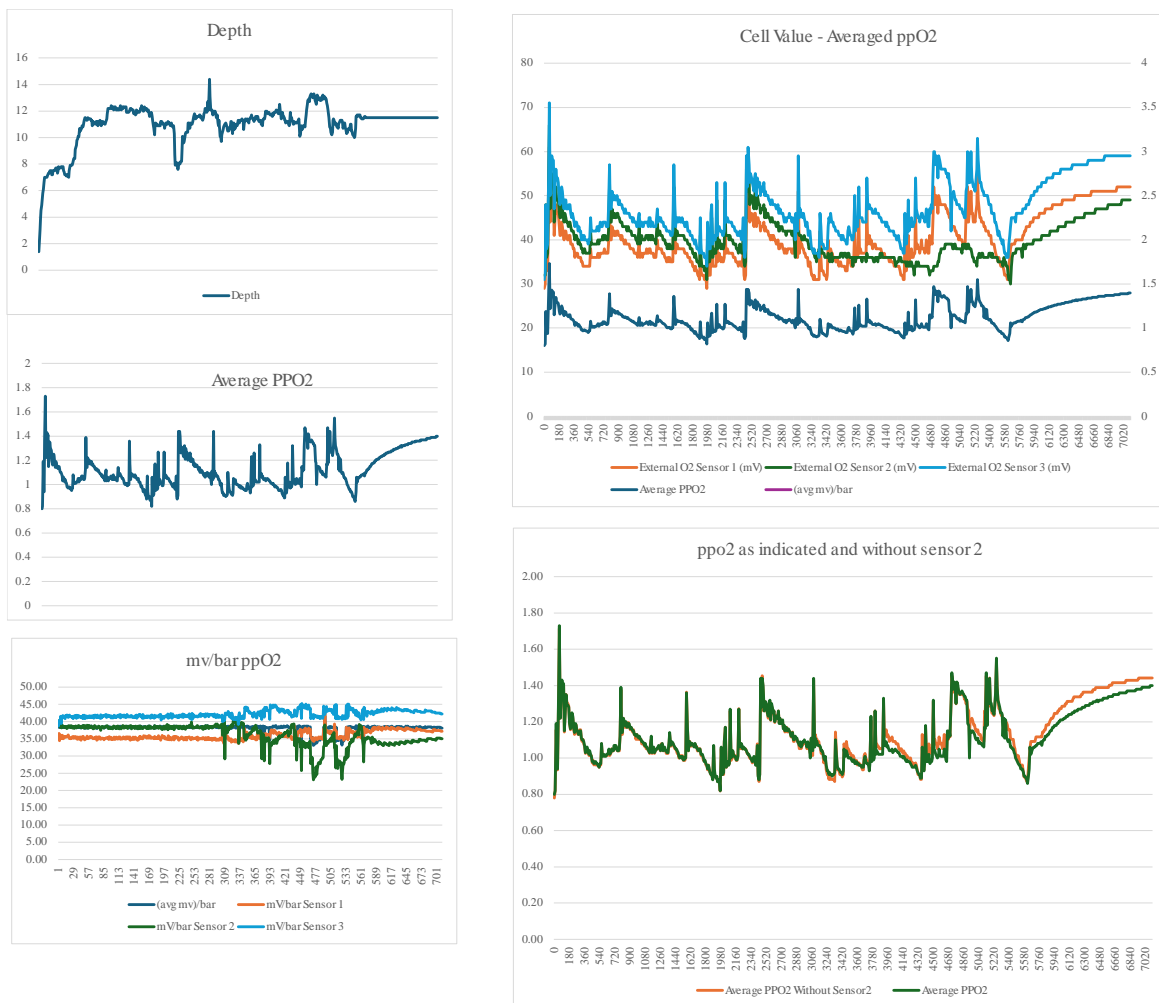
The dive computer log shows an average PO₂ of around 1.14, with a series of spikes corresponding to a manual addition of oxygen or a change in depth. This is usual for a constant mass flow rebreather. Some of the spikes approached a PO₂ of 1.6, and on one occasion at the beginning of the dive reached 1.73, but the indicated PO₂ alone is unlikely to be high enough to cause a CNS oxygen toxicity hit, unless these readings were erroneous.

Analysis of previous dives logged indicates some erratic cell behaviour and data indicates Diver 1 potentially conducted some shallow test dives to validate cells. One cell appears to stop working on a dive on 30 January

2024. It is possible that Diver 1's rebreather could still have been experiencing intermittent cell issues, but the data from the dive does not indicate high PO₂ as the sole triggering factor for unconsciousness or convulsions.
